TITLE: The Utilization of Advanced Composites in Military Aircraft
(L'Emploi des Materiaux Composites de Pointe pour les Avions Militaires)

ENVIRONMENTAL DEGRADATION OF HIGH TEMPERATURE COMPOSITES

R. C. Cochran T. M. Donnellan R. E. Trabocco
Naval Air Development Center
Warminster PA 18974 USA

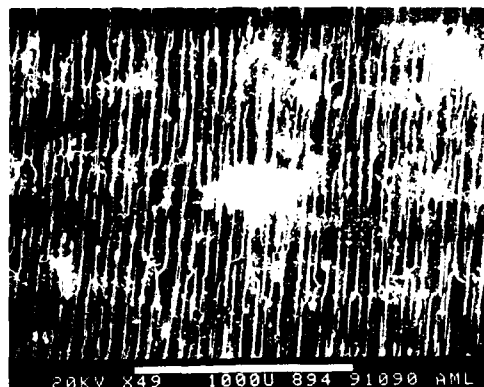
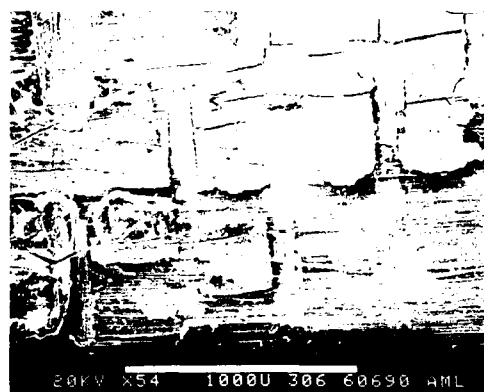
A Above degradation

B In the degraded area

C In the degraded area

Figure 3 Electron micrographs of degraded surface

After 4 days of exposure the samples were removed from the solutions and inspected with optical and scanning electron microscopy (SEM). Examination of the water/fuel exposed specimens showed that the resin had been completely removed from the fibers on the surface in the area just above the interface. The resin higher up the specimens in the fuel phase but still in the affected zone was cracked and fibers were visible below the surface. SEM micrographs from three areas are shown in figure 3. The specimens exposed to only water had much less exposed fiber, however the cracks and chipped resin were more visible over the surface. The resin had been thinned down a great deal on these specimens. SEMs of the surface of the water fuel samples showed that the resin was heavily cracked above the degraded area, figure 3A. Moving down the specimen a large number of rough chips were observed on the surface of the specimen, figures 3B. Finally in the area of greatest degradation there were fibers with a thin resin coating, bare fibers and chips of resin visible, figure 3C.

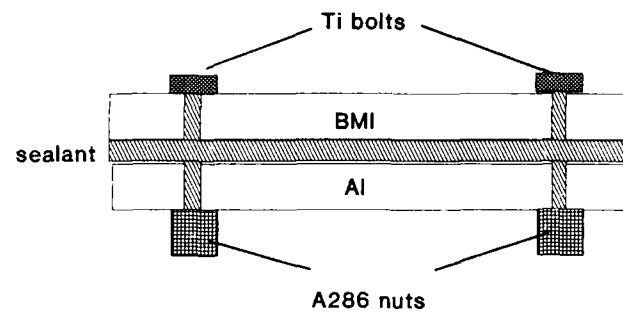
Figure 5 Salt spray exposure specimen

composite and aluminum specimens were 2.5 cm X 10 cm. (1 X 4 in.). A MIL-S-85430 polysulfide sealant was applied to the faying surface and the fasteners were coated with uninhibited polysulfide sealant before installation. Two .468 cm (3/16 inch) holes were drilled one half inch from the edges of the specimens. The samples were connected using titanium 6,4 alloy bolts with an A286 alloy nut. The assembled specimen is shown in figure 5. The test matrix used in this evaluation is shown in table 2. The variables examined included the fiberglass ply, the sealant, the type of primer, and the condition of the primer. Specifically, bare and glass covered samples with and without polysulfide sealant with either a solvent based (MIL-P-23377) or a water based primer (MIL-P-85582) were evaluated. Some of the coated composite samples were heat aged at 149°C (300°F) for 100 hours before they were assembled. After the sealant had fully cured (1 week) the samples were exposed in a salt spray chamber. Most of the specimens were exposed for 30 days. In addition, another set of specimens which were fabricated with MIL-P-23377 primer, MIL-C-82582 and 825-009 high temperature urathene primer were exposed for 90 days. The exposure conditions for all of the salt fog specimens conform to the ASTM G-84 specification.

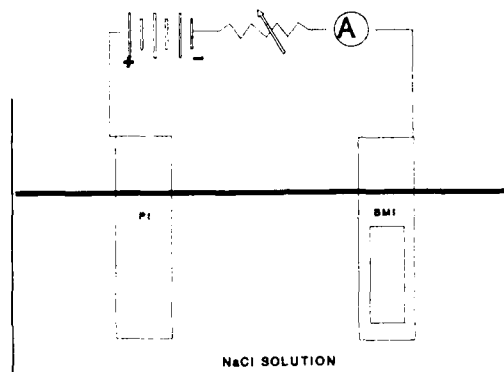
Figure 7 Electrochemical cell

In an effort to determine which variables in the process most strongly effect the rate and severity of degradation, a factorial test matrix was developed. An electrochemical cell was used to expose the BMI composite to various environments. The variables evaluated included salt concentration, oxygen concentration, pH, time, current density and temperature. Two levels of each variable were evaluated. The levels of each variable were as follows: Salt concentration .1 and 3.5%, aerated and deaerated water, pH 7 and 11, 1 and 4 day exposure, temperatures of 25°C (75°F) and 83°C (180°F) and current densities of 40 and 160 micro amps per square centimeter. The specimen consisted of a 24 ply 5250-4 composite. Electrical connection was made to the composite by drilling a hole, sanding both surfaces to expose fibers, coating the hole and area around it with silver filled paint and installing a steel nut and bolt with the wire lead. The test area was then masked off and the specimens primed with epoxy primer and topcoated with urethane paint. Three samples were exposed at each condition listed in table 6. The test cell with the specimen is shown in figure 7. The composite specimen was the cathode and the platinum mesh electrode the anode. This cell allowed the duplication of the reactions in the freely corroding cell. Each test was replicated three times to eliminate extraneous results.
